WATERLOO STANDARD CONDOMINIUM PLAN No. 437 - WHISPERING PINES
345 Briar Meadow Drive
Kitchener, Ontario

**RESERVE FUND STUDY
2014**

Project Number: 14-1062

November, 2014

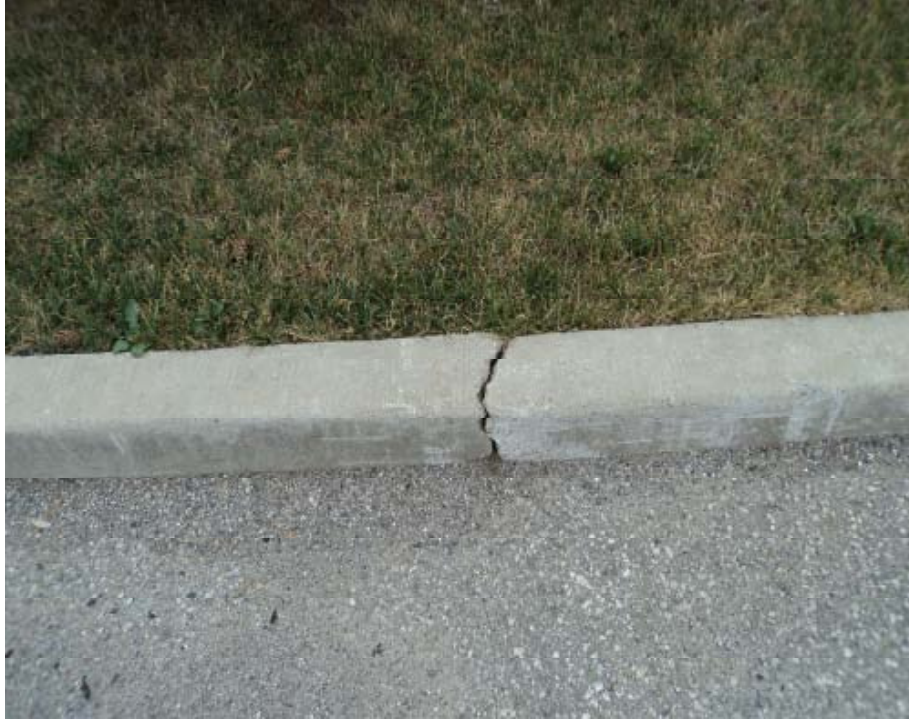
The concrete curbs around the parking lot have areas of cracking and pieces broken off. It would be our recommendation that localized repairs to the curbs be completed. We recommend that these repairs be completed as part of the ongoing maintenance budget.

Photo 1 –Cracks in the curb.

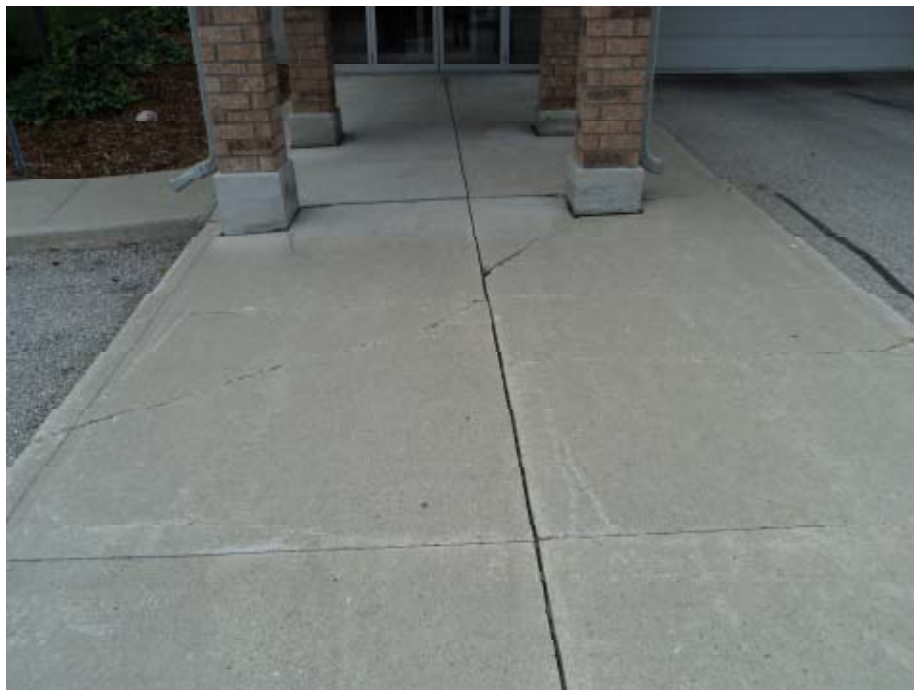
There are two concrete walkways and three pavestone patios located on the site. The concrete walkways at the main entrance to the building and the south side of the building are cracking and are tripping hazards. We recommend repairing the concrete as part of the maintenance plan.

Photo 2 – Main entrance side walk to the complex. Note cracks

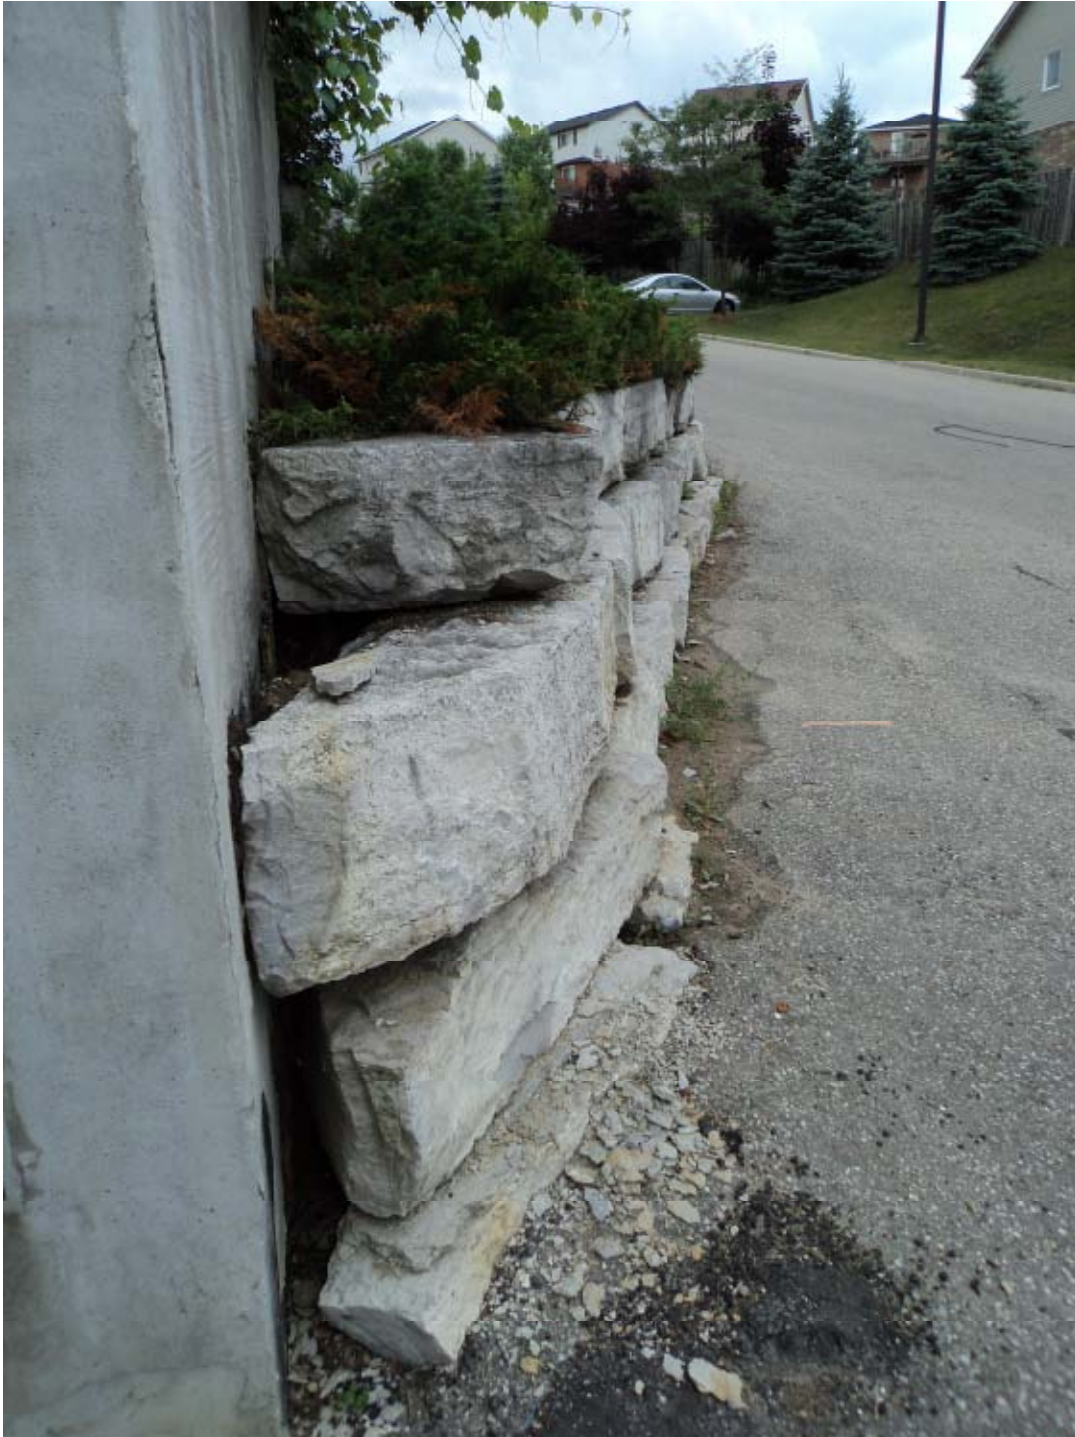
There are two retaining walls on the property, both being constructed with landscaping blocks. One located on the west side of the parking area beside the parking structure entrance. The other retaining wall is on the east side of the property enclosing the shared common patio area. The retaining wall on the west side of the building beside the parking structure entrance is chipped and has a gap between the building wall and landscaping blocks. This is to be monitored and if further deterioration is observed the Corporation should consider partial removal and re-waterproofing. Cost for this work will be extensive and hence funds have been allotted for the reserve fund has been accounted for in this reserve fund.

Photo 3 – Retaining wall west side of building by parking garage.

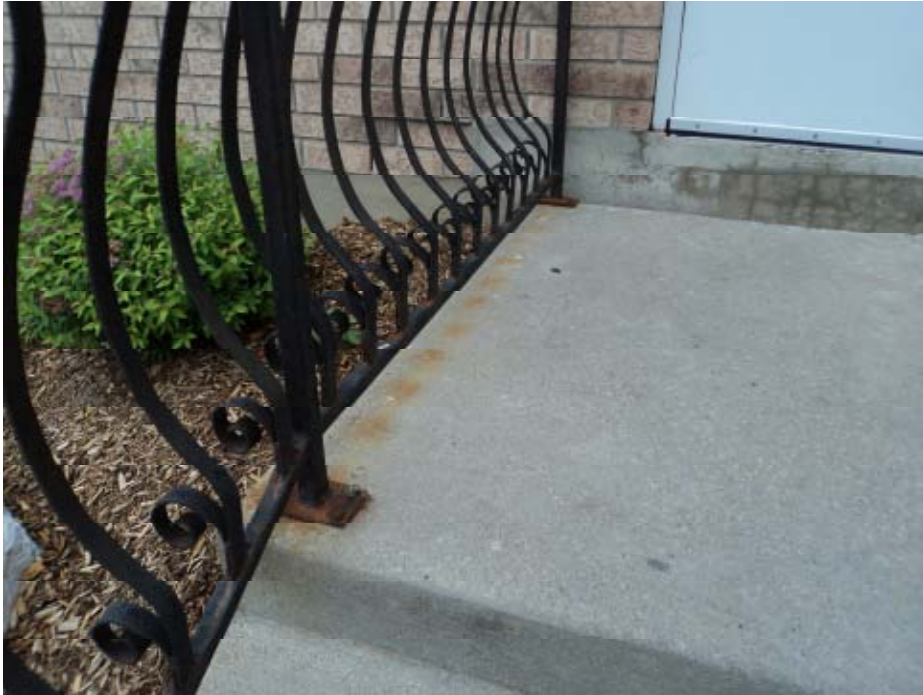
There is a metal railing on the south side stairs existing the building. The railing is rusted at the bottom. We recommend touching up the paint on the railing to prevent any further rusting. We recommend that this repair be completed as part of the ongoing maintenance budget.

Photo 4 – South side stair railing

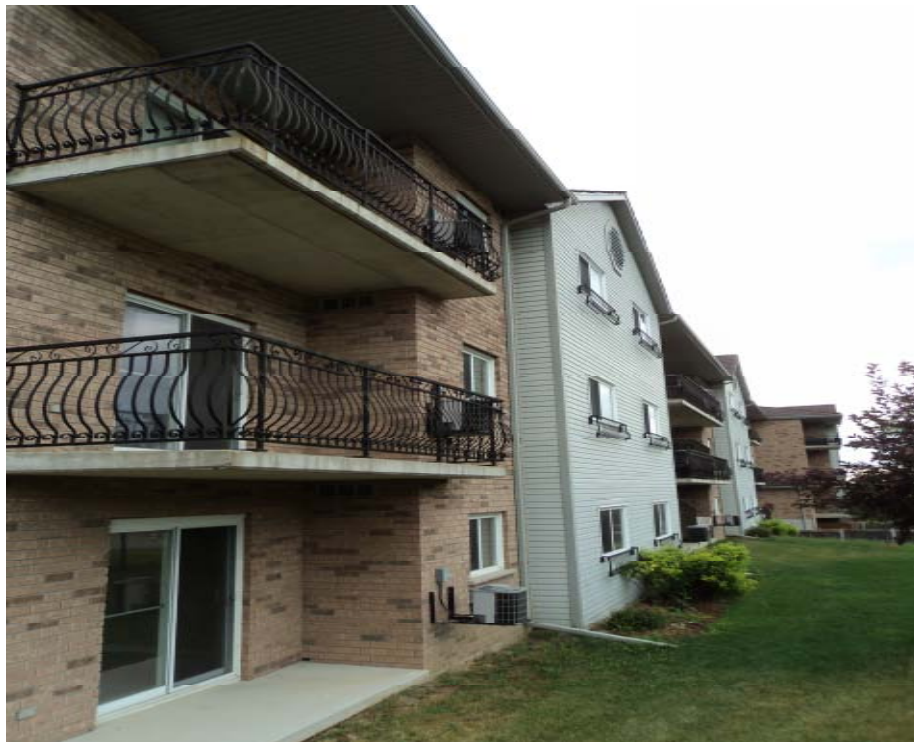
Each unit is complete with either a concrete patio or a balcony. The balconies are enclosed by a 42" (1070 mm) high powder coated metal railing. All the balconies are reinforced pre-cast concrete slabs and are approximately 6" thick. The balconies for the units measure approximately 54 sq.ft. (~5 sq.m.). In general, the balcony slabs appear to be in good condition with no evidence of efflorescence, spalling or delamination.

Photo 5 – Typical concrete balconies.

Concrete balcony slabs are often susceptible to corrosion-related deterioration, like spalling and delamination, due to their exposure to moisture. In time, the embedded reinforcing steel will begin to corrode causing the steel to expand thus forcing the concrete covering the steel to spall and delaminate. Therefore, it is important that the tenants refrain from placing any flooring materials on the balcony slabs that may hold the moisture. Balcony slabs normally require rehabilitation at some point. We have suggested including some funds to complete this work when the balconies are 25 years old.

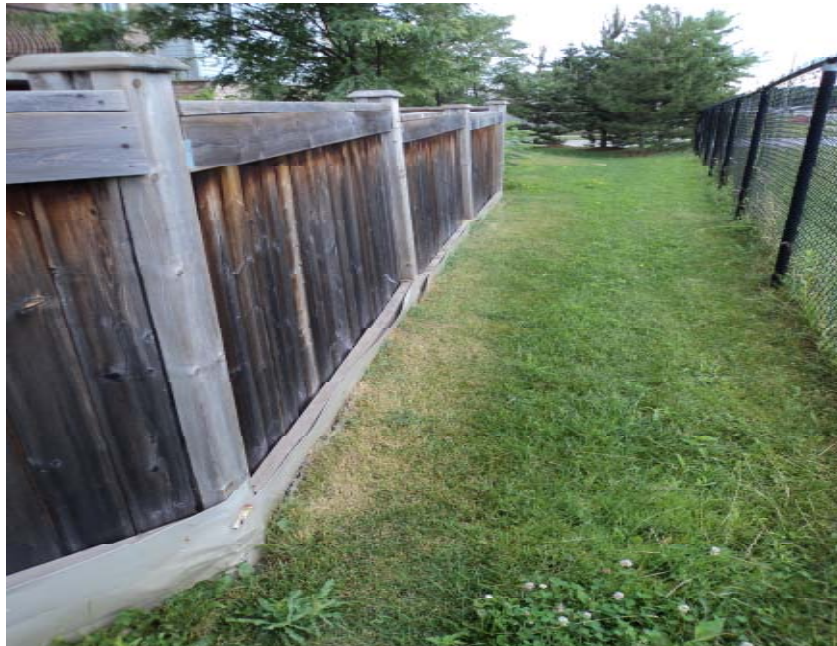
In general the wooden fence is in fair condition. A regular maintenance program of changing the boards and should be undertaken as part of the ongoing maintenance program post replacement.

Photo 7 – Typical wood fence around patio area.

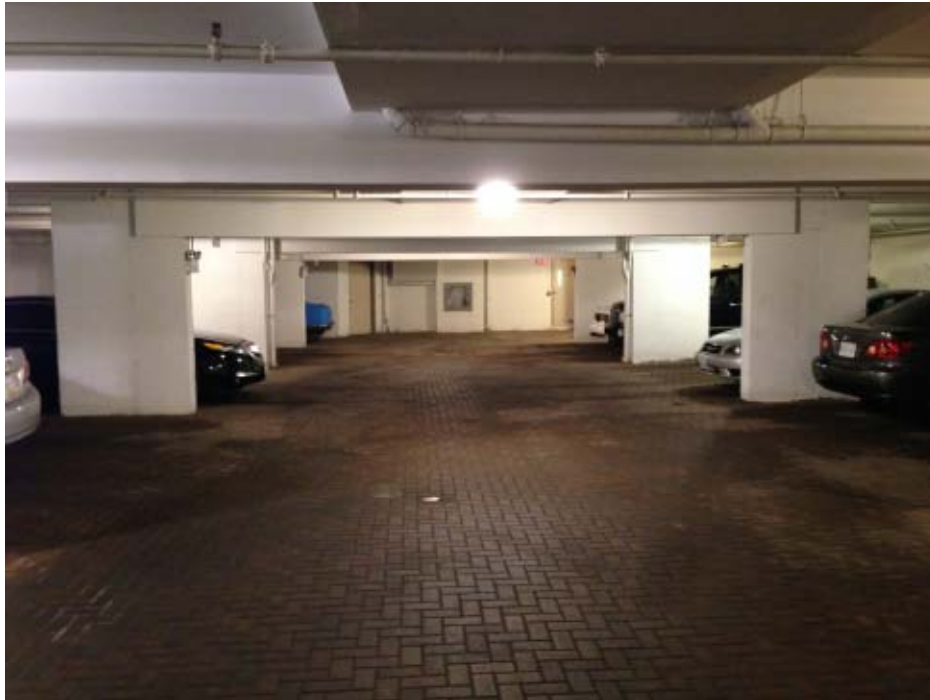
The parking structure is constructed of cast-in-place concrete walls supporting the 'Hambro' floor system. The exposed ceiling in the parking garage is painted gypsum board on resilient channels. The parking structure is lit with 12 high pressure sodium light fixtures. Drainage of the parking structure is achieved with two catch basins. The interlocking brick that makes up the floor of the parking structure appears to be in good condition.

Photo 8 – Parking garage area with interlocking pavers.

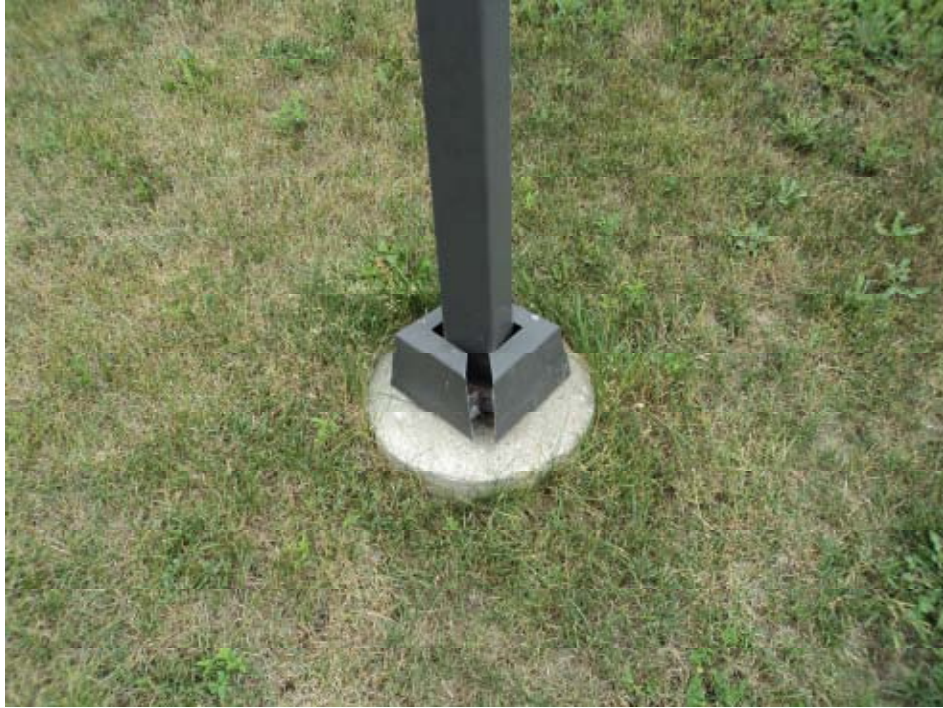
Photo 10 – Parking lot lighting fixture base ajar.

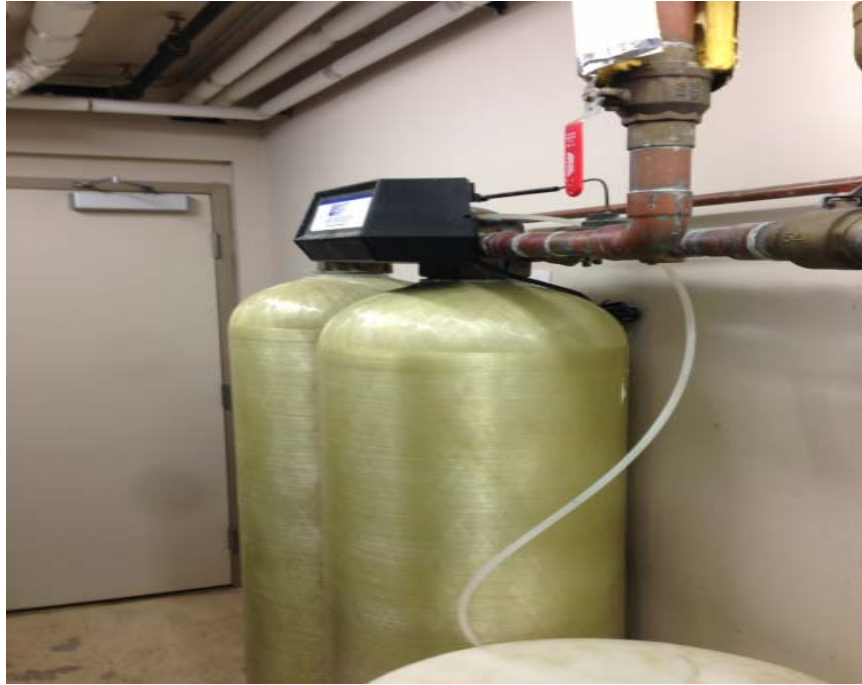
The building uses a gas fired boiler with two storage tanks for hot water distribution throughout the building. The boiler and storage tanks appear to be in good condition. The building is equipped with a double tank water softener system. With proper maintenance it is still expected that the water heating system should achieve their lifespan of 15 to 20 years possibly longer depending on the severity of the hard water.

Photo 12 – Two tank water softener

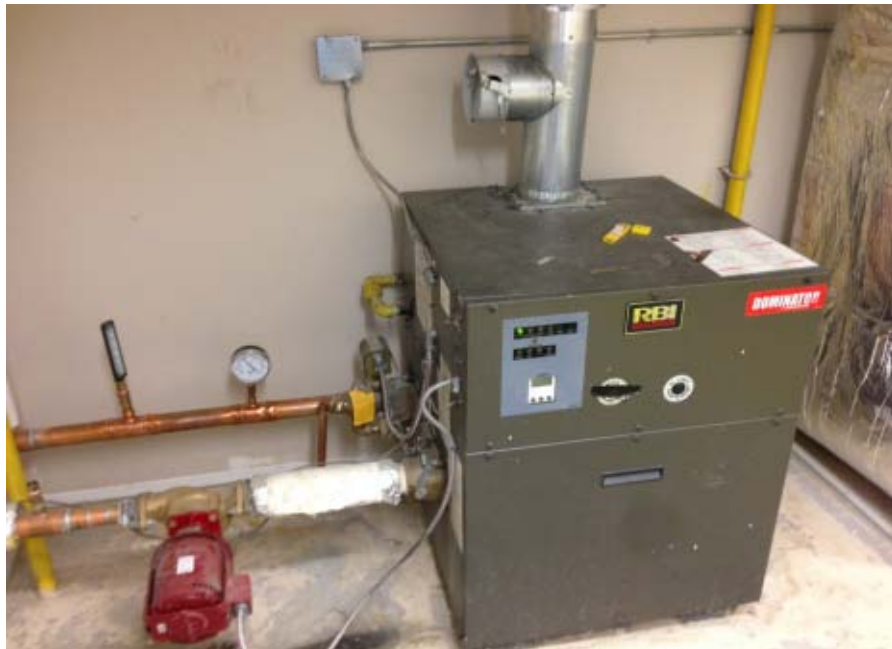
Photo 13 – Boiler located in Mechanical room.

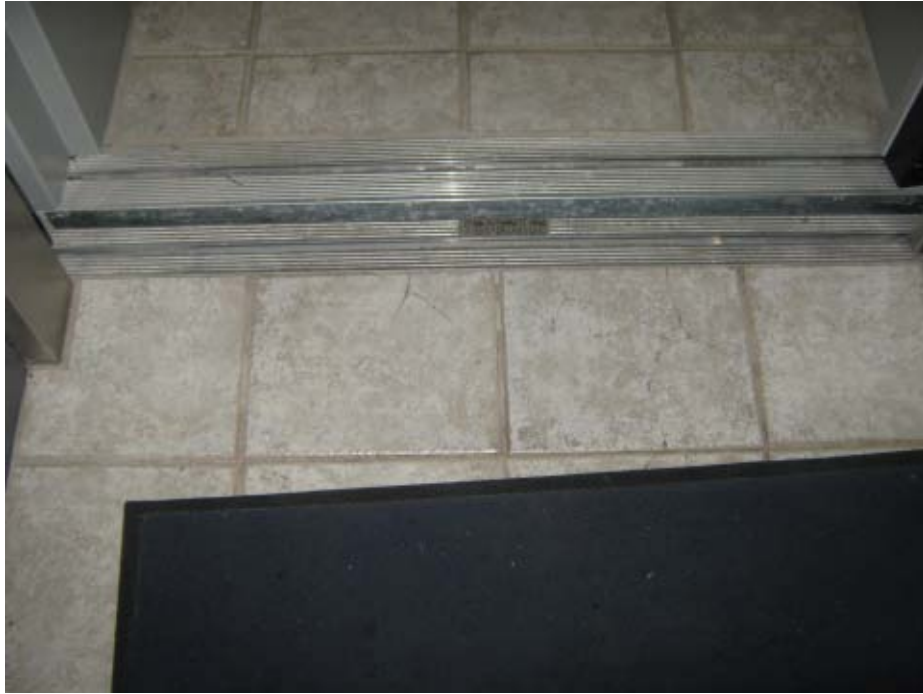
Photo 14 – Cracked ceramic tiles in elevator.
